Leaking from the Vertical ASA

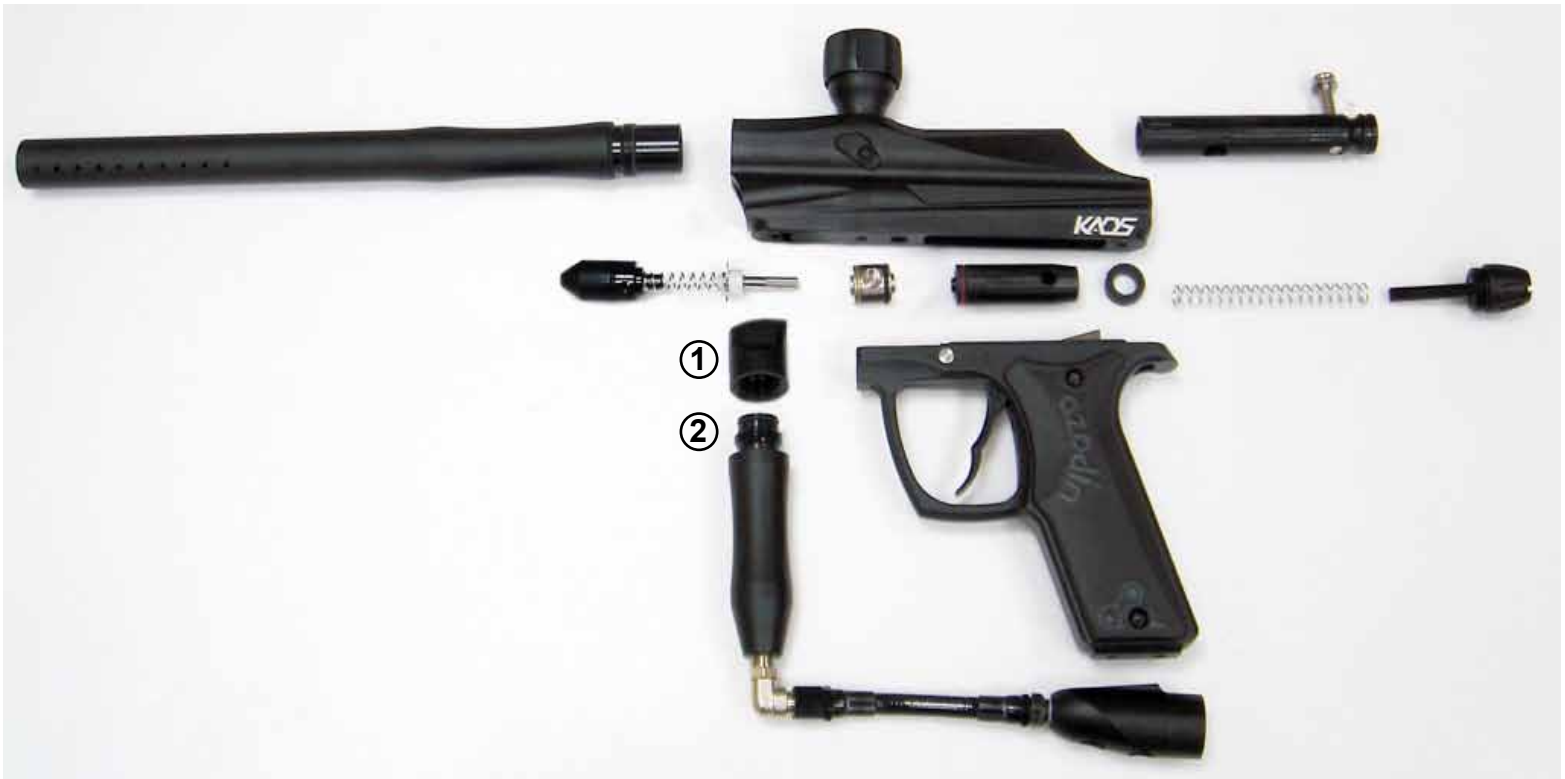
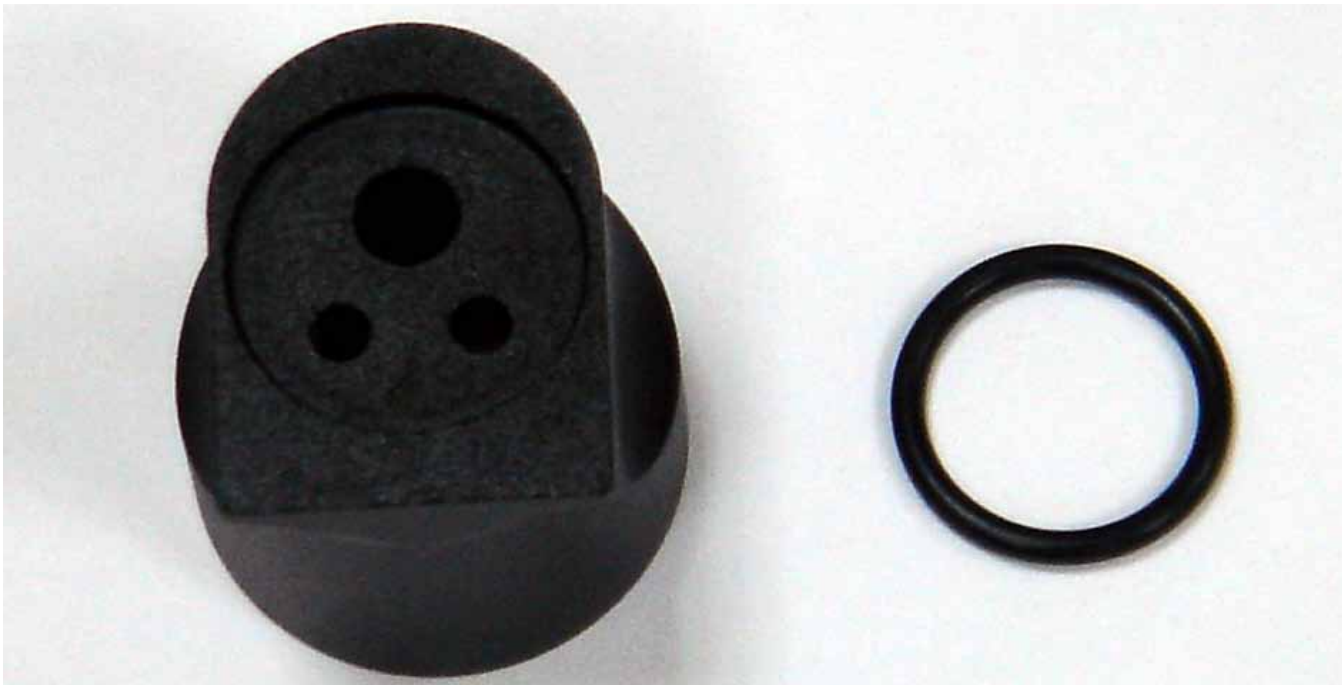
POSSIBLE CAUSE: AZ O-ring (R015) is damaged

SOLUTION: Replace AZ O-Ring (R015)

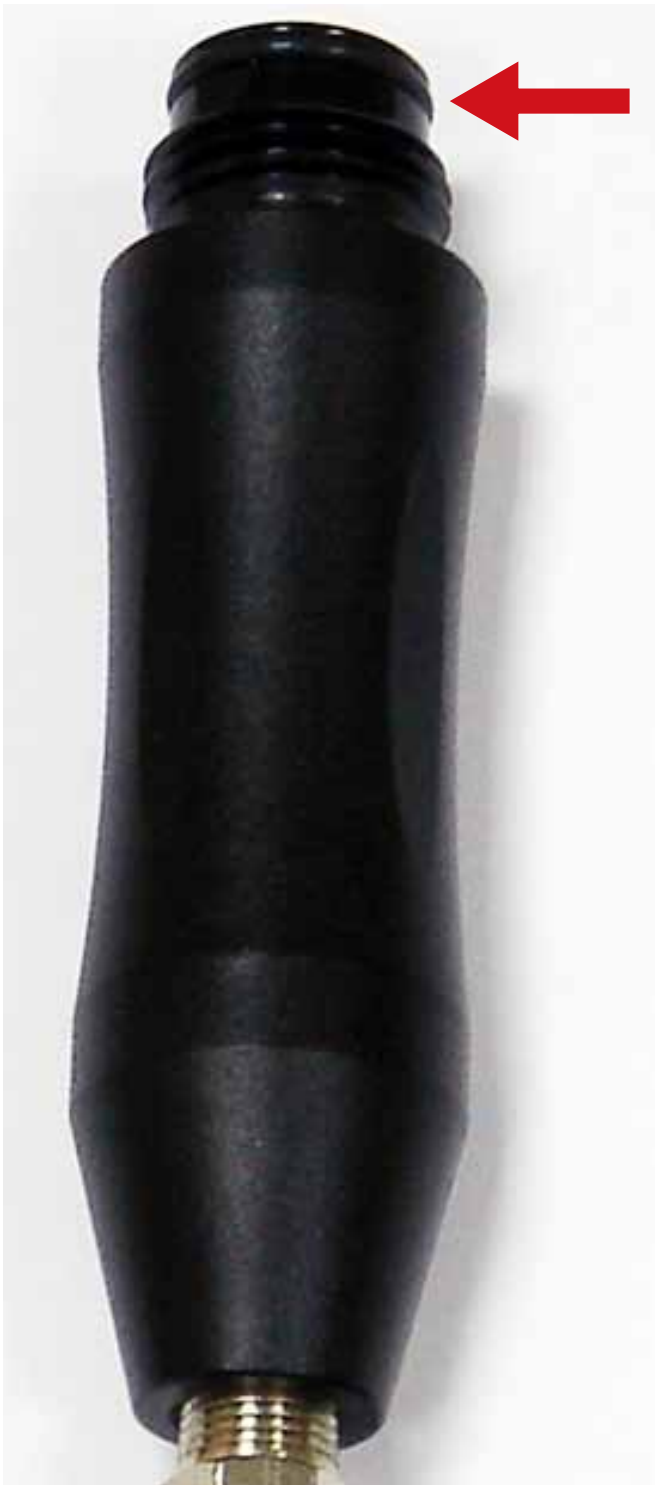
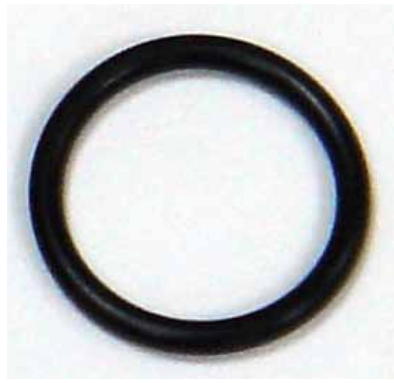
POSSIBLE CAUSE: AZ O-ring (R015) is damaged

SOLUTION: Replace AZ O-Ring (R015)
