Leaks down the barrel

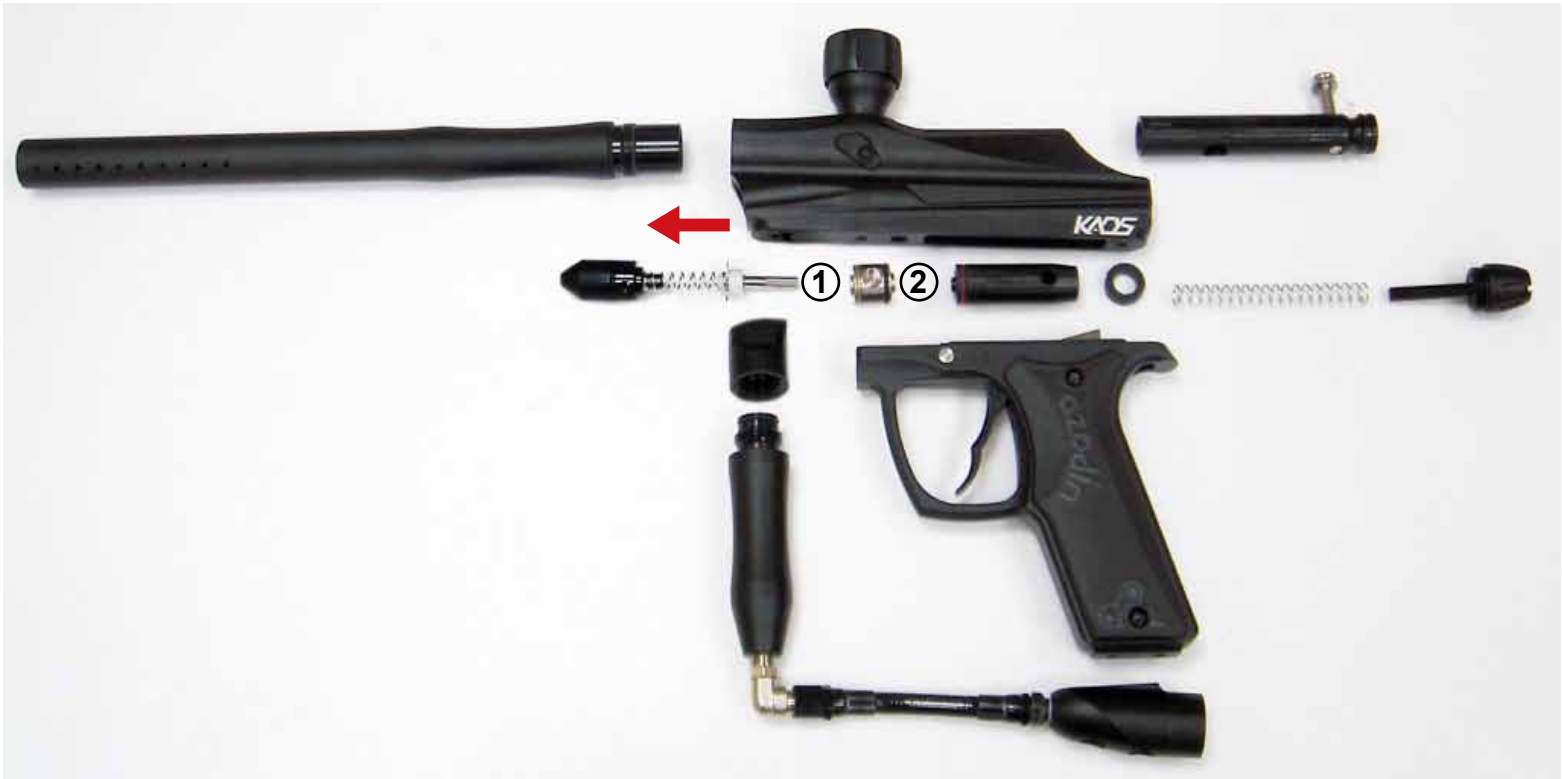
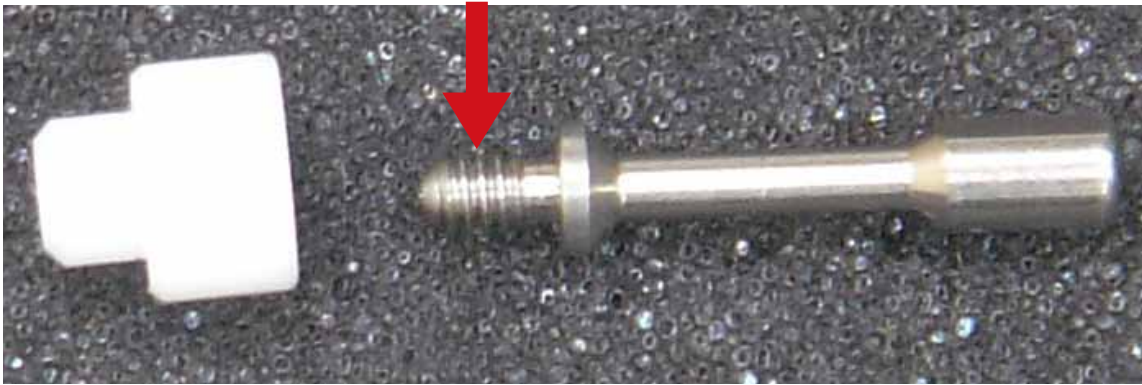
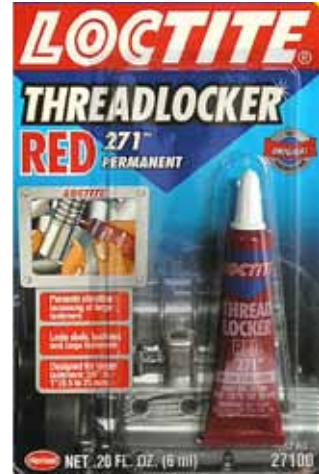
LOCTITE

POSSIBLE CAUSE: Cup seal or cup seal guide is damaged or loose

SOLUTION: Replaced cup seal or cup seal guide/ Apply Loctite on the threaded side of cup seal guide. Loctite needs 24 hrs for successful drying

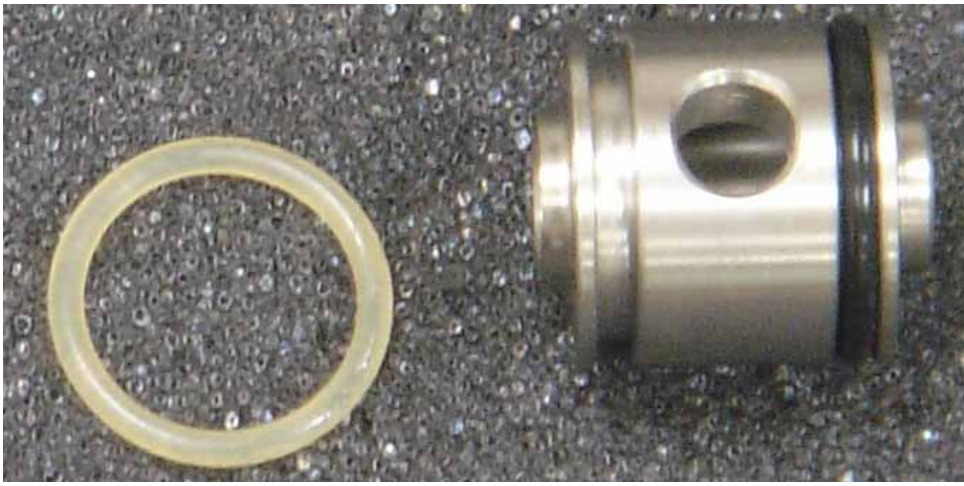
POSSIBLE CAUSE: Front Valve O-Ring (R012) is damaged

SOLUTION: Replace Front Valve O-Ring

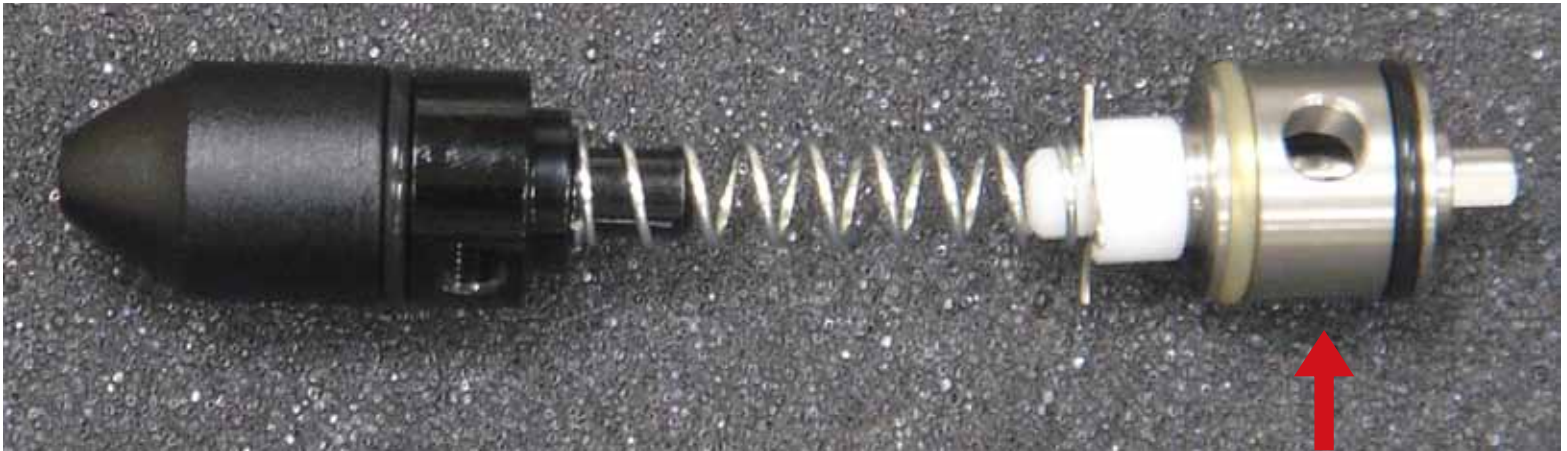
POSSIBLE CAUSE: Damaged Valve

SOLUTION: Replace Valve
