# Leaking from ASA

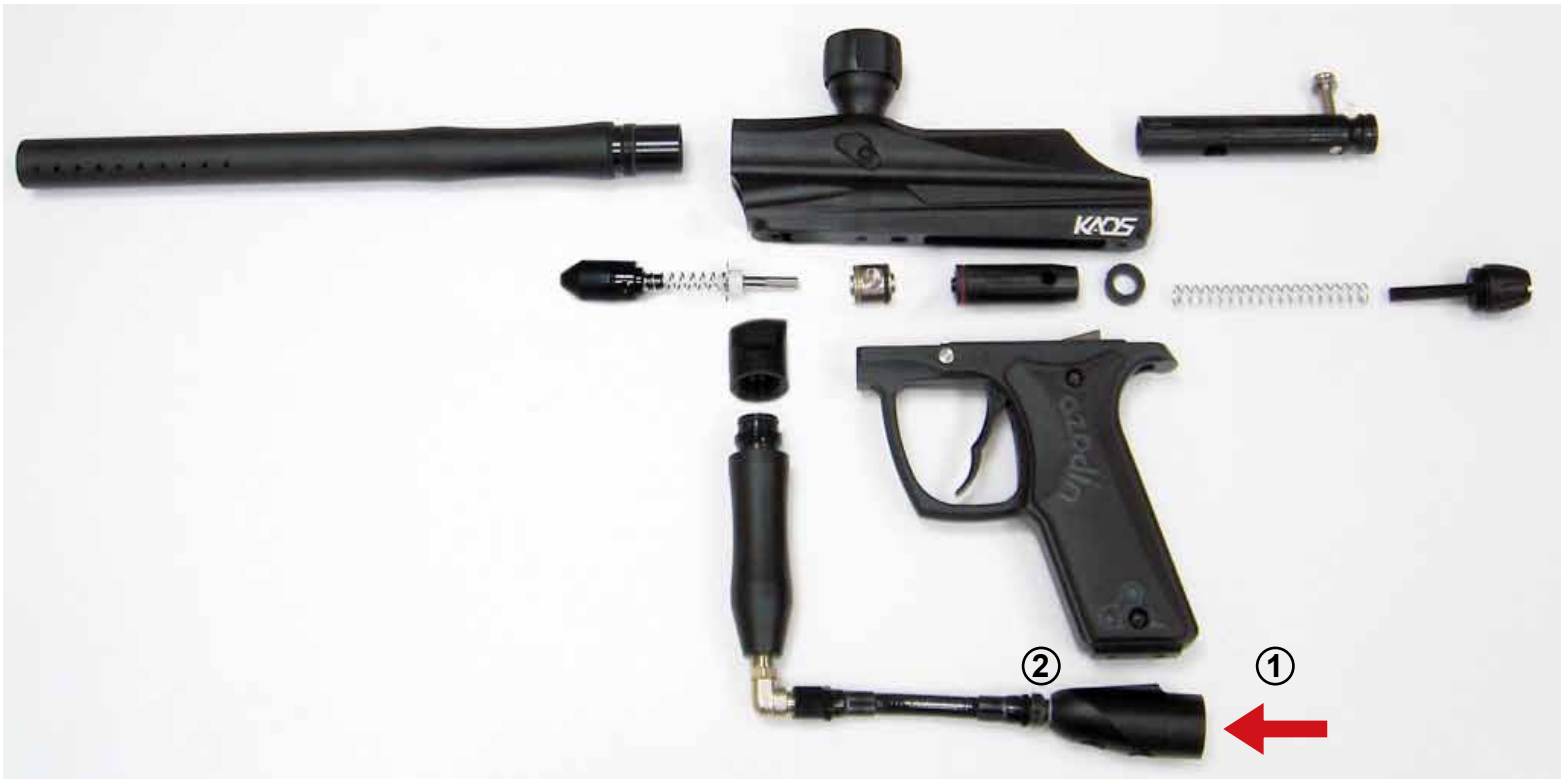
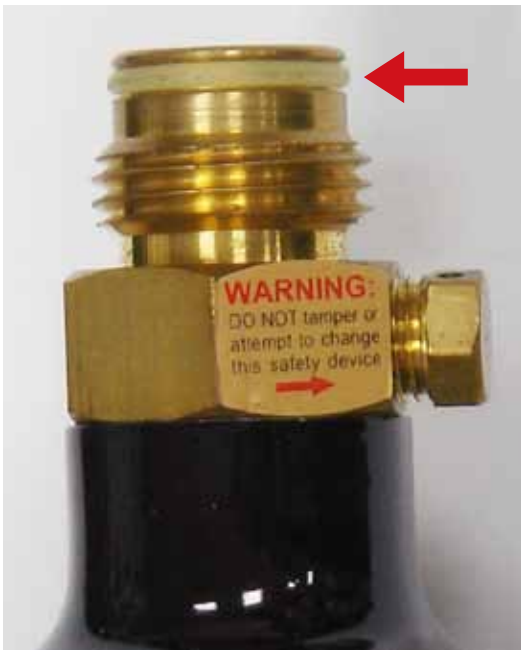
**POSSIBLE CAUSE:** O-Ring on the air tank is damaged

**SOLUTION:** Replace the O-Ring on the Air Tank

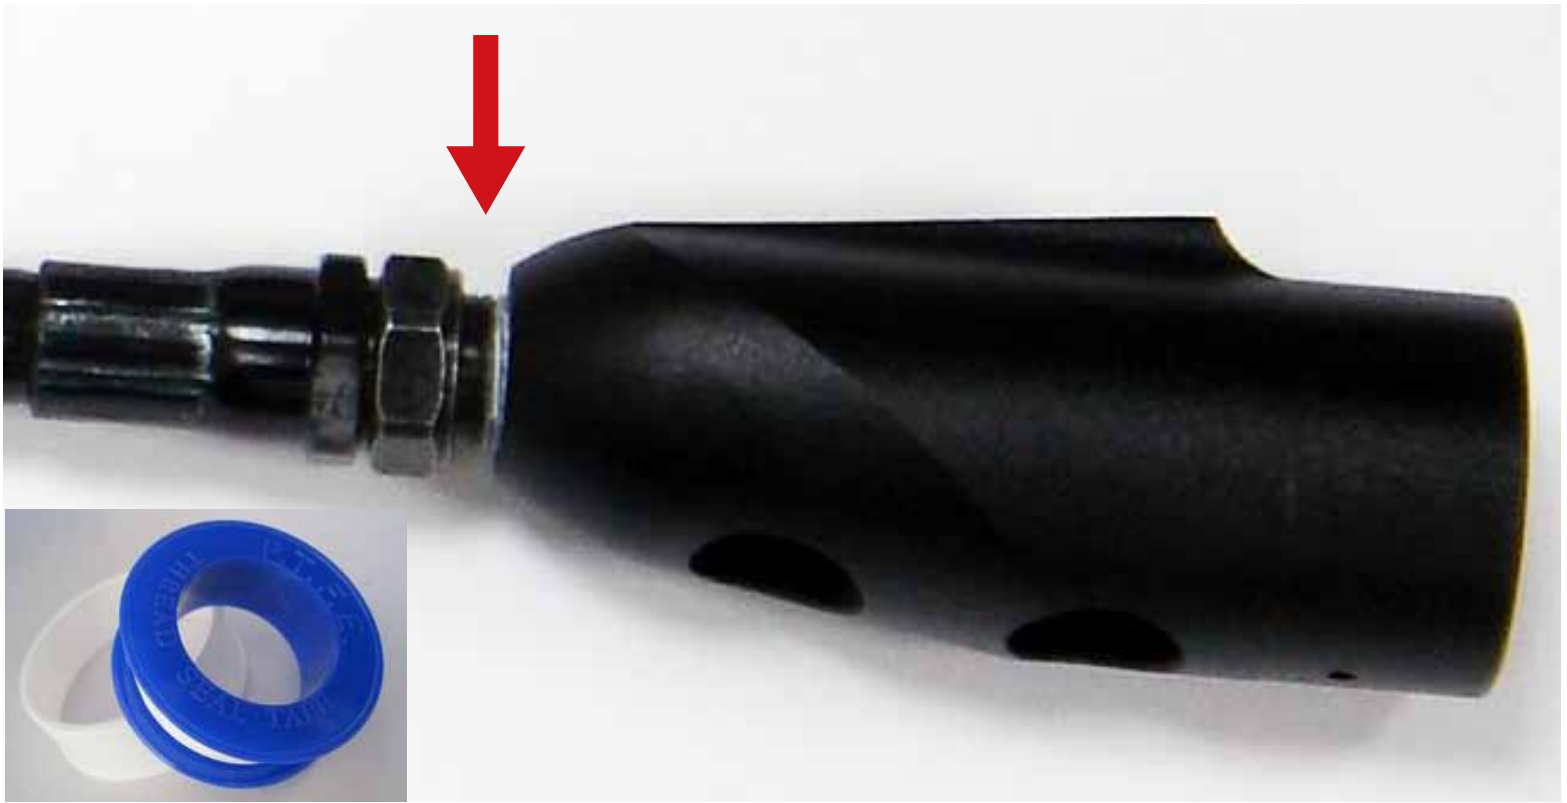
**POSSIBLE CAUSE:** Braided Hose ( P071) is loose from Bottom ASA ( A021)

**SOLUTION:** Apply Thread Seal Tape and reconnect Braided Hose to Bottom ASA.
